Name of Organization: Geesay Lanka prints (pvt) Ltd

NC No. : 01 of 01

Relevant Standard : ISO 45001: 2018 Auditor : -

Relevant Clause : 8.1.1

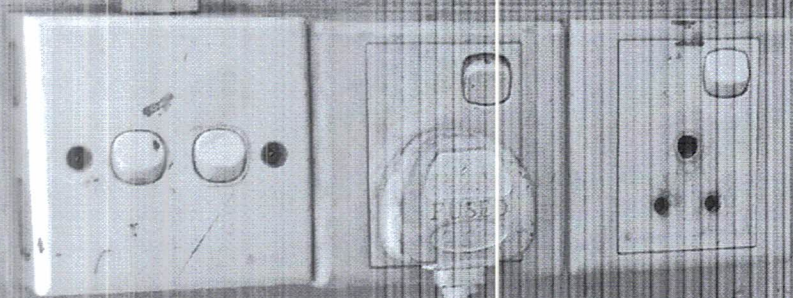
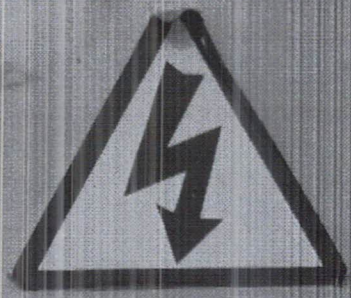
Danger
230 Volts

DANGER
ELECTRIC SHOCK RISK
අනතුරුදායකයි

Warning!
KEEP THE ELECTRICAL DISTRIBUTION
BOARD AREA FREE AND CLEAN.

- ① Removed the unused wall fan.
- ② Fixed a Suitable Plug top.
- ③ Fixed a new lock and cleaned properly & closed.
